AREA OF CONCERN

SOLUTION

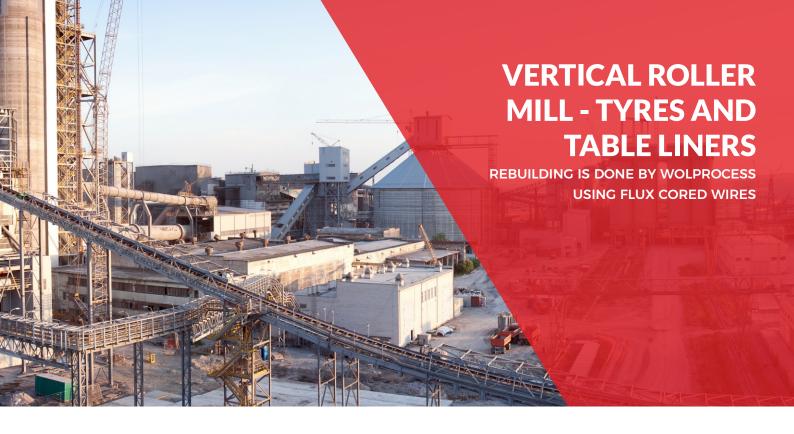
The tyre & table liners wear out due to impact and abrasion. The gap between tyre & table liners as well as crushing angle change reducing the output of the VRM thus reducing efficiency & increased power consumption.

Rebuild the worn-out surface by automated, electronically controlled WOL process using flux cored wires. The WOL deposit is far superior than the base material, metallurgically, offering excellent wear resistance. With our FCW, it is possible to rebuild multiple layers for as high as 80 mm thickness!

- · Removal of old hard deposit & levelling of surface
- NDT of rollers/roller segments/tyres & table liners
- Weld build-up hard deposit and matching profile/ angle
- Finishing
- Inspection
