AREA OF CONCERN

VRM bridge pipe is a series of pipes that help in feeding and discharge of materials to the Vertical Roller Mills.

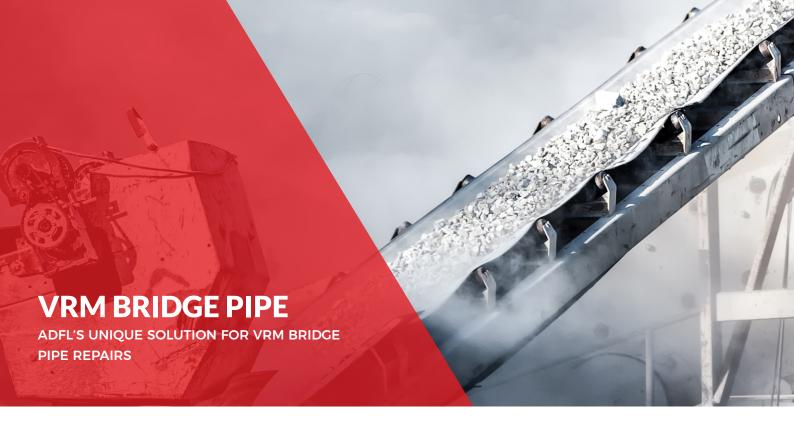
The vertical roller mill (VRM) is used by all major cement manufacturers for grinding limestone, coal & cement. The VRM bridge pipes are used for feeding and discharge of material, these VRM bridge pipe gets cracked due to heavy vibration. Replacement involves high cost and stoppage. The lead time for spares involves huge downtime and production loss. The most critical aspect of this application is that customers require an in-situ repair with improved life enhancement at shortest possible time.

Ador fontech solution to this problem is the joining of the crack area of the VRM bridge pipe. The crack occurs in the area of pipe joining the VRM casing & also around the adjoining areas of the pipe. V-grooves are formed in the crack area and aligned and then joining is done by a unique combination of our welding alloy LH-1105 used as a buttering layer & completed joining done by our unique life enhancement alloy LH-521 which combines high tensile strength & high elongation to provide long life to the repaired component.
