AREA OF CONCERN

SOLUTION

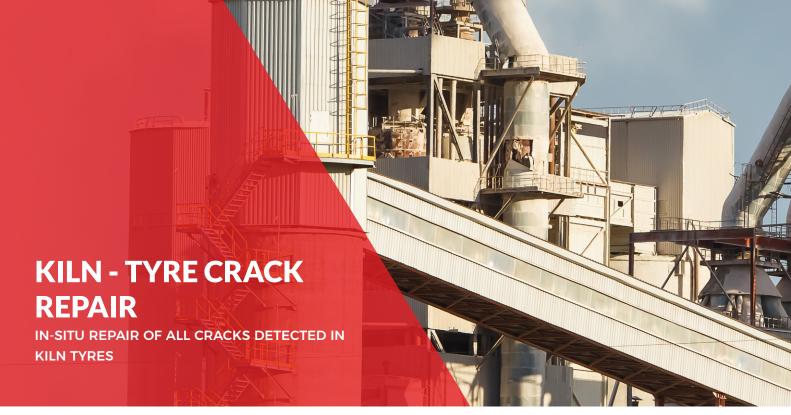
The crack may develop rapidly in tyres if the Kiln is continued to work. Tyres are casted and not readily available. Lead time to supply may vary from 4 months to a year and mostly imported. Huge down time resulting in production loss as well as cost involved in tyre replacement. Developed CREEP may cause further damage to other parts of Kiln if tyre is allowed to run without repair.

Detect and repair cracks in tyre, carry out PWHT and run the kiln till new tyre arrives. Ador has performance proven welding consumables & Quick Response Team to undertake this repair work.

- NDT of tyre to mark exact location of cracks
- · Arresting cracks to prevent further propagation
- Removal of cracks & surface preparation
- · Weld build-up
- PWHT & finishing
- Inspection
